ASIC/IC - Debugging & Troubleshooting

Sub-micron probe station

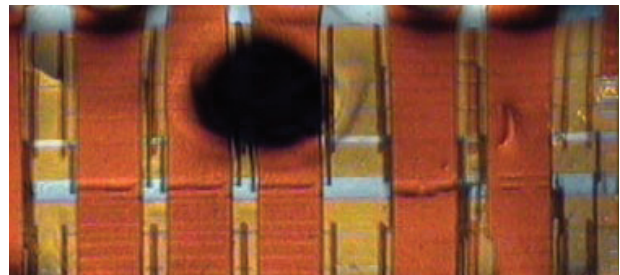
Hot spot analysis - Hot spot detected by use of liquid crystals.

Together with the equipment in our laboratory and the experience of our team, the ALESSI REL-6100 probe station, with laser and micropositioners, is a powerful tool when debugging any type of integrated circuits. The laser can open top glassivation for direct line probing and it can cut lines to bypass parts of the circuit. The probe station is also very suitable for detection of leak current by the use of liquid crystals, the so-called "Hot Spot Analysis".
